NASA CR-2075

**RESIDUAL STRENGTH AND CRACK
PROPAGATION TESTS ON
C-130 AIRPLANE CENTER WINGS
WITH SERVICE-IMPOSED FATIGUE DAMAGE**

Prepared by
LOCKHEED-GEORGIA COMPANY
Marietta, Ga. 30060
for Langley Research Center

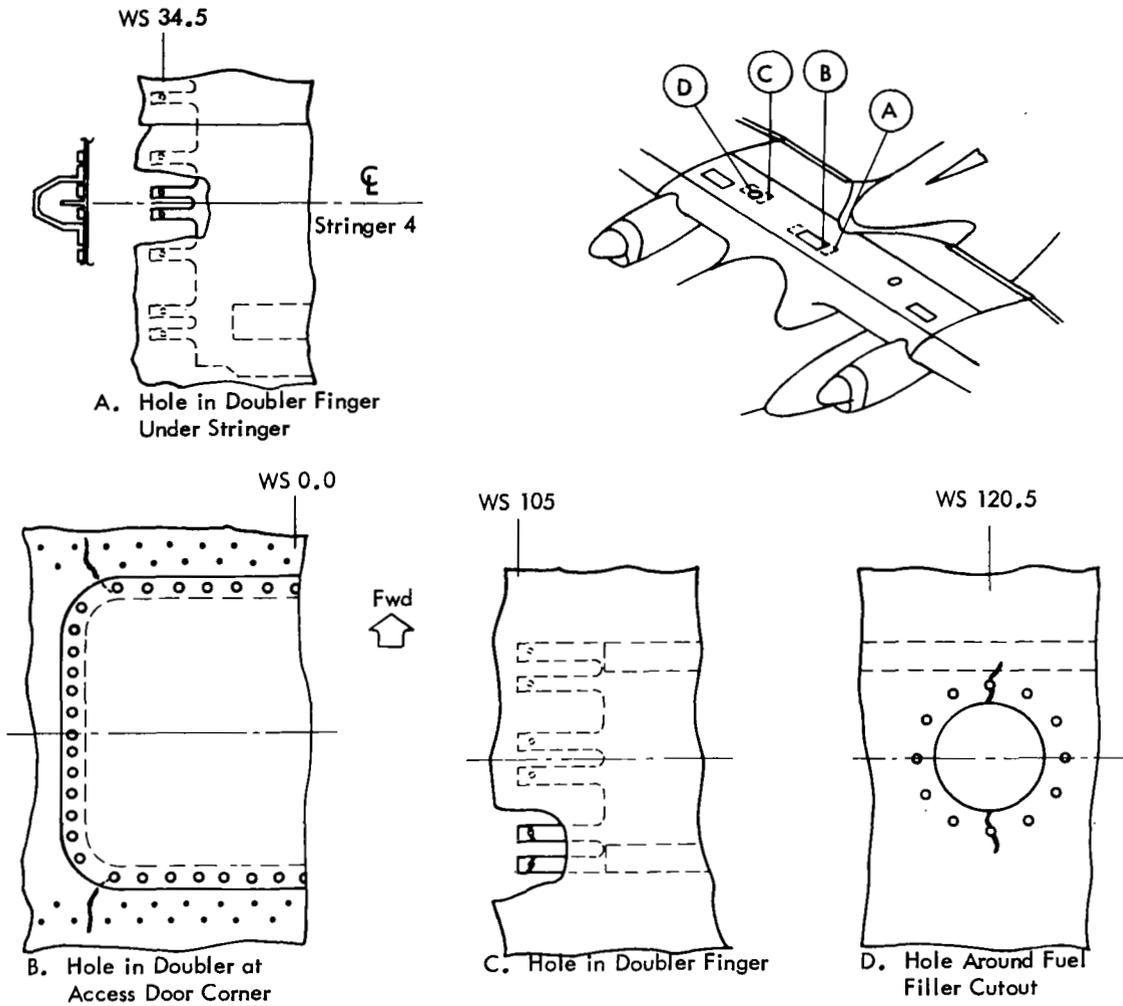
Each of these panels is further stiffened by the installation of three spanwise stringers made from 7178-T6 extruded hat sections spaced at 6.6 inch intervals and installed with riveted attachments except at the spanwise splices. The spanwise splices are butt joints with an extended leg of a hat section stiffener forming a splice plate and fastened with steel lockbolts. Basic upper surface skin thickness of the machined panel is 0.100 inch for the entire span of the center wing. The principal structural discontinuities, which are illustrated in Figure 3, occur approximately symmetrically in both wings, and are at the transition structure immediately inboard of the W. S. 220 production joint; at the W. S. 180 access door cutout; the W. S. 120.5 fuel filler cap opening, and at the inboard (W. S. 105) and outboard (W. S. 135.5) ends of its reinforcement doubler; at the W. S. 61.5 wing-fuselage support rib; and at the dry bay access door cutout at W. S. 1.5 and the ends of its reinforcing doubler at W. S. 34.5/37.5. These are the locations where most of the upper surface fatigue cracks originated during service.

Figure 3. - Typical areas identifying upper surface skin cracks originating in fastener holes.

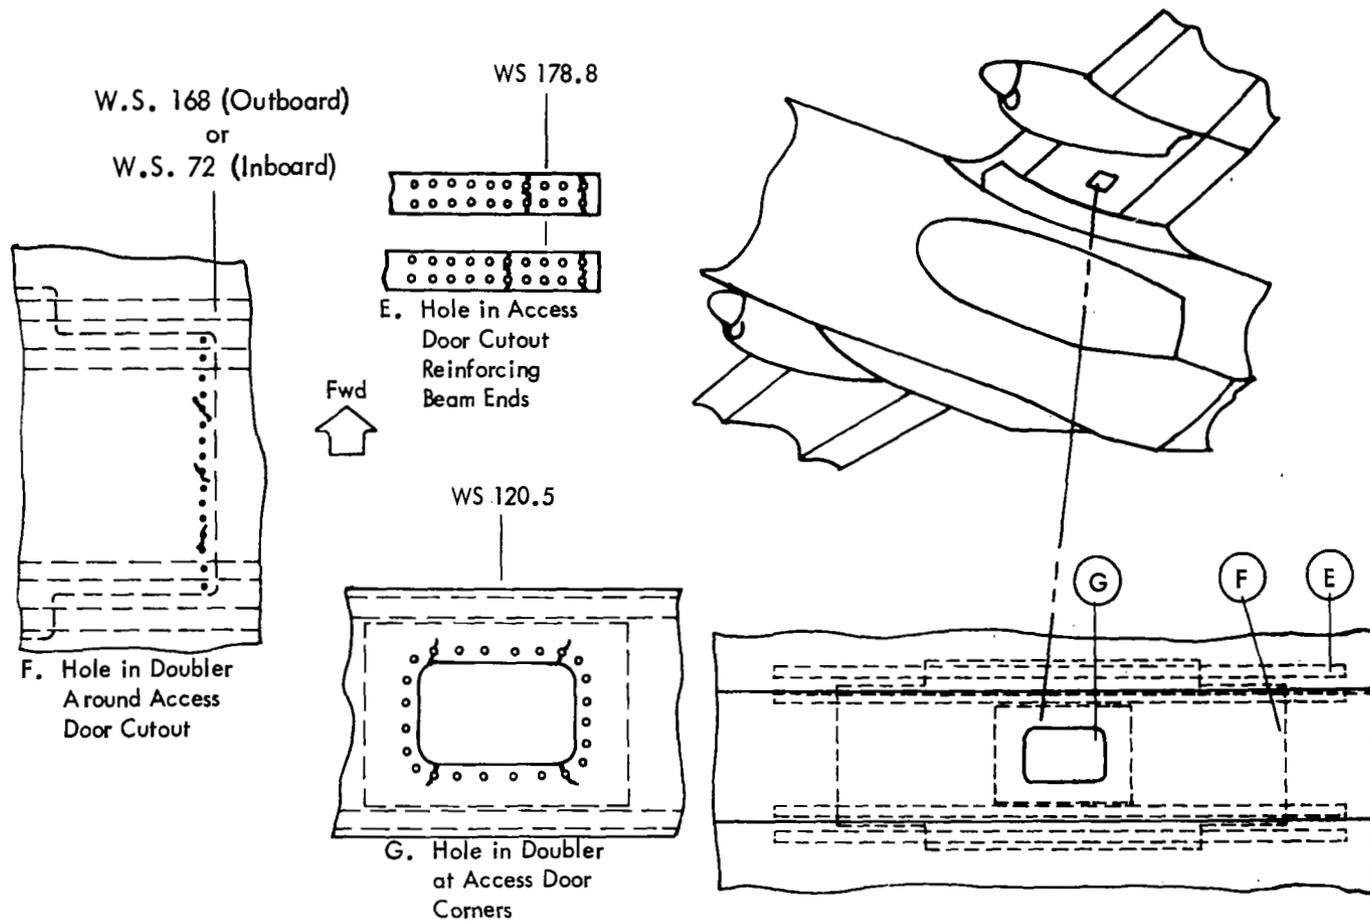
Specimens #1, #2, and #3 were tested to evaluate wing lower surface crack propagation characteristics under increasing levels of static load. Predominant initial damage from service fatigue on all three of these specimens was at W. S. 176, near the termination of the spanwise reinforcing beam (see Figure 4). Their residual strength failure loads fell within a narrow range of 114 percent to 116 percent Limit Load at W. S. 176. Crack history is shown in Table 6.

Figure 4. - Typical areas identifying lower surface skin cracks originated from fastener holes.

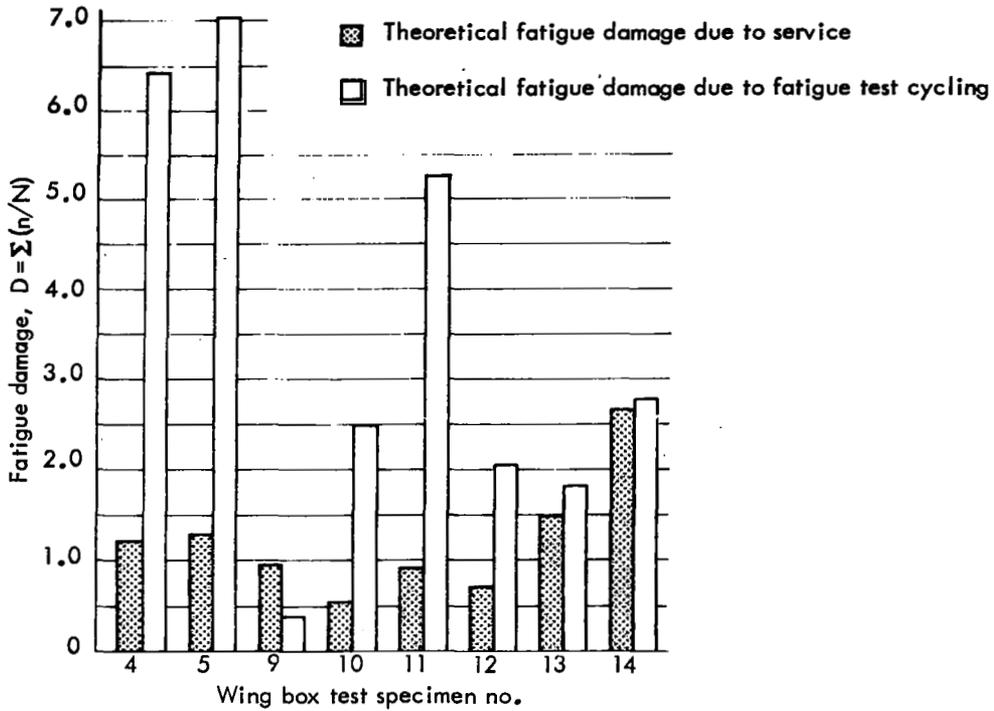
Figure 7. - Comparison of fatigue damage: service vs. test cycling

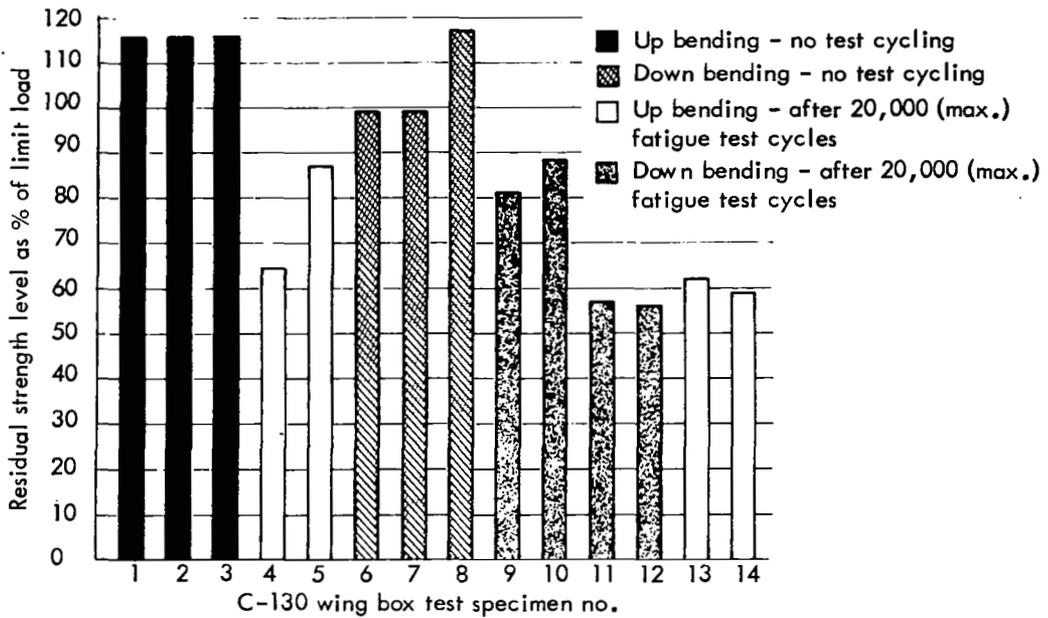
Propagation behavior of the largest cracks is summarized in Table 3 for upbending tests and in Table 4 for downbending tests. The initial crack length, crack growth after cycling, and the final crack length at failure are noted. Failure loads achieved during residual strength test are shown in Figure 8 for each test specimen. Notes used to describe crack length data throughout the report are listed in Table 5. The more important numerical data on extent and location of initial cracking, formation of new cracks, and crack propagation records are shown in Tables 6 through 15; a comprehensive crack history for all 14 test specimens is given in Reference 1.

Figure 8. - C-130 wing box residual strength.
